# HC Series Troubleshooting

Rev. 1.6

RISO KAGAKU CORPORATION  
Overseas Technical Department  
12 February 2008

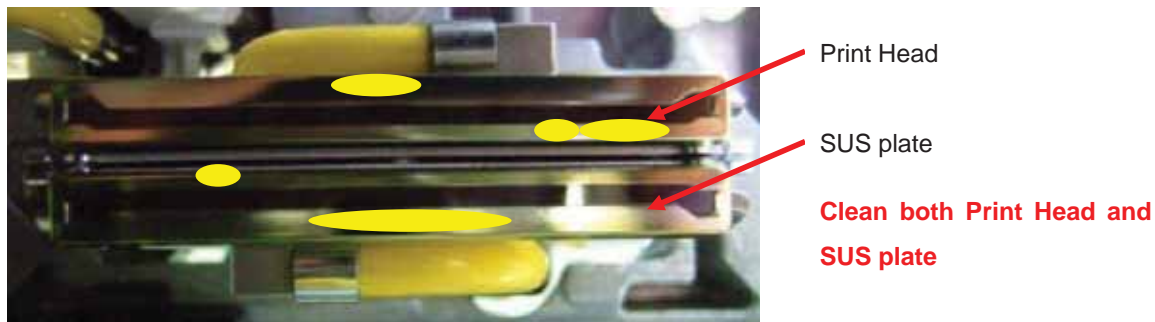
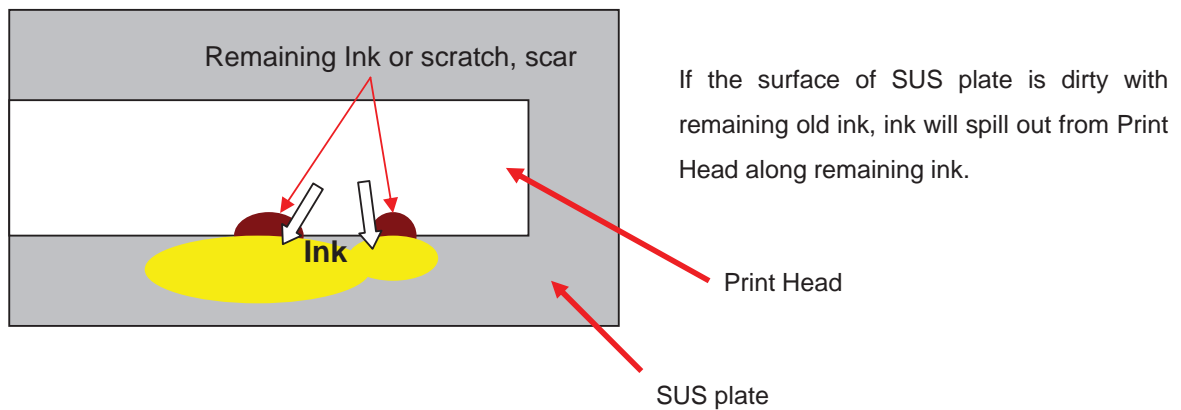
### Cause of the problem (1)

If the surface of SUS plate is dirty with remaining old ink, ink will spill out from Print Head along remaining ink.

Remove remaining old ink on SUS plate manually with fresh ink.

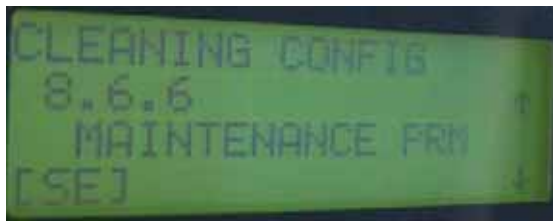
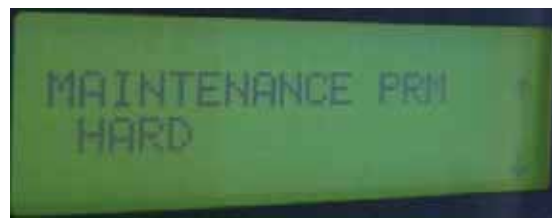
### Cause of the problem (2)

- The compressed air in the Reservoir will be released at the end of Print Head cleaning action and to what extent this air releasing is performed is affecting the ink meniscus of Print Head.
- You can change the air releasing level by **SE mode 8.6.6** and there is a trade-off condition between the misfire and ink spilling trouble.

- Adjust the "CLEANING CONFIG" by **SE mode 8.6.6** (HC5500)
- This parameter has the values of OFF(default), WEAK, NORMAL and HARD.(HC5500)
- When [ HARD ] is selected, the possibility of the ink spilling trouble will decrease but the possibility of misfire will increase.

If there are many ink drips on the Print Head even if change parameter to "HARD", it is necessary to replace **ink reservoir** or to clean up the Print Head again.

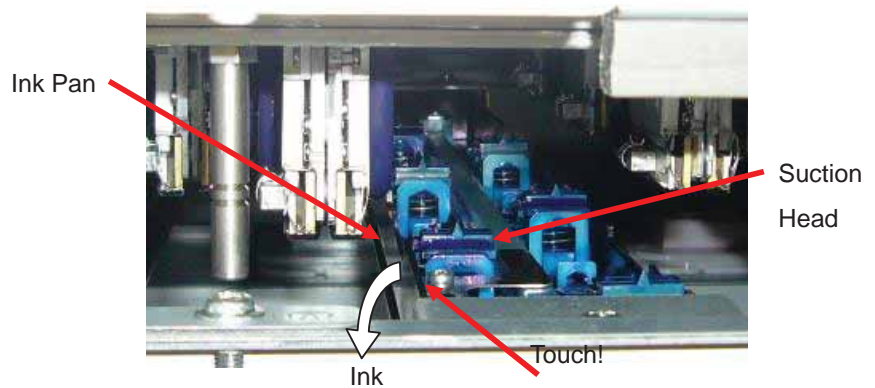
**There is a problem in the stopping position of maintenance unit.**

- If the stopping position of maintenance unit is not proper during Print Head cleaning operation, Suction head cannot wipe the surface of Print Head sufficiently.

- If there is a problem with the stopping position of maintenance unit, Ink might drop down from "Ink Pan" because the "Suction Head" touches "Ink Pan".

- Repair the deformed unit or replace the unit.

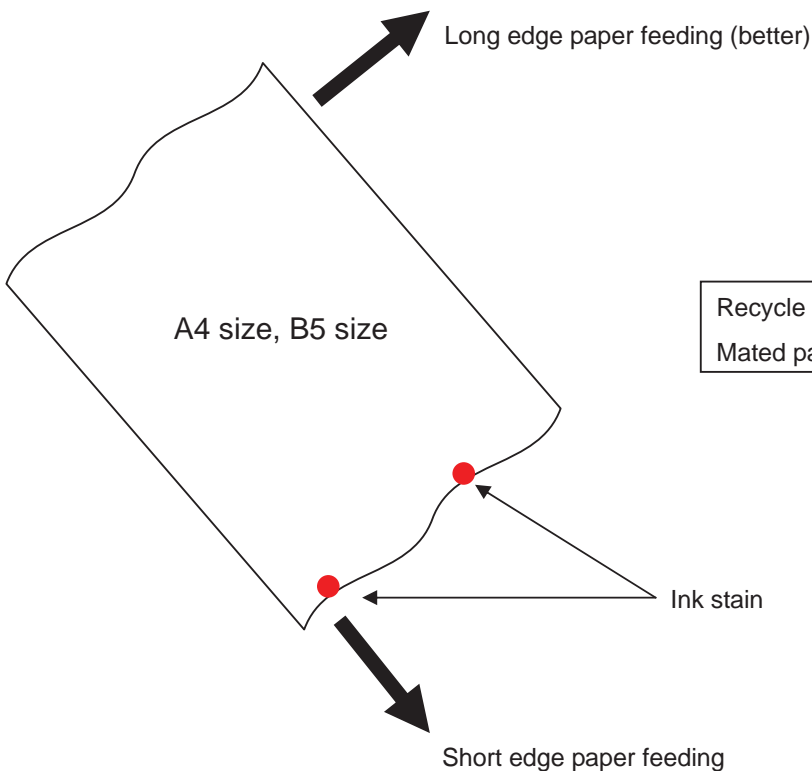
Due to curled paper or waved paper, edge of paper is stained.

- If curled paper or waved paper is used for printing, the paper will touch the surface of Print Head slightly and the leading edge of the paper will be stained with ink.
- In worse condition, the error **X02-223** [Paper lift detection] will occur.

Curl of paper

Wave of paper

- Change papers with non-curved and non-waved papers if possible.
- Change the paper feeding direction if the paper size is small or than A4. (Short edge paper feeding -> long edge paper feeding)
- Use the paper feeding from Multi-Tray Paper Feed Tray to avoid influence of the outside air. And putting "silica gel" is effective for humidity.
- Remedy of paper curl.

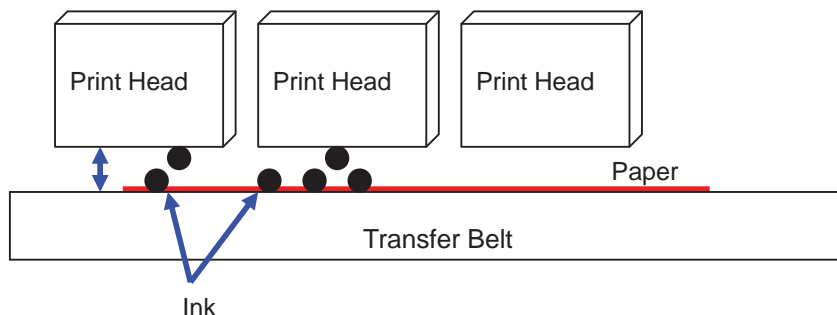
**The gap between Print Head and the transfer belt is too far.**

- Ink mist, a minute particle of ink, may be sometimes generated from Print Head during printing.
- Such ink mist drifts in the air and comes toward the transfer belt.
- Most of them reach to the paper on the transfer belt so it is a problem.
- But if the gap between Print Head and the transfer belt is too far, misting ink may reach to the transfer belt and it can be misting a cause of the problem.
- As a result, the surface of the transfer belt becomes dirty with ink and the edge of paper gets stained with ink.
- If the margin around the printing paper is reduced by **menu 4.10** [Print Area], this problem occurs easily.

The gap is big

- Adjust the gap by **SE mode 5.9.1.32** for HC5000. (It is possible to widen with 0.1mm step)
- The gap is alternated automatically by the paper type. If you print normal paper with envelope setting, the gap becomes too big.(HC5500)
- Adjust print area(margin) by **menu 4.10**.(HC5000, HC5500)

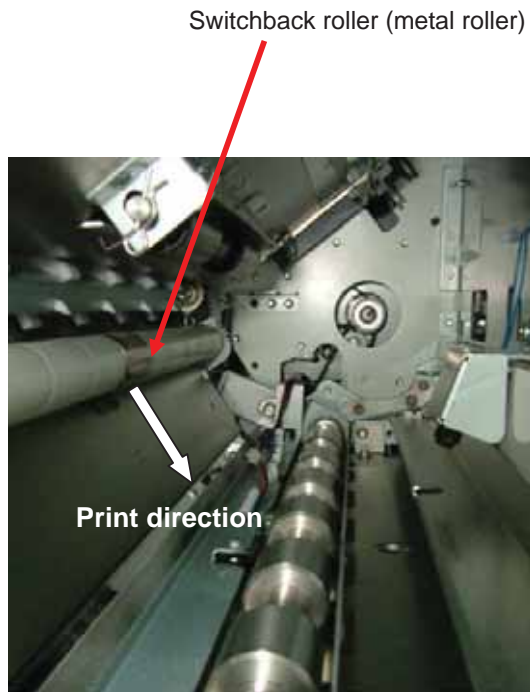
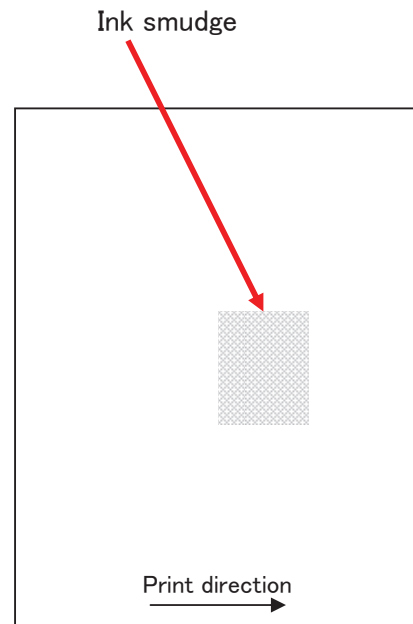
Item 1-3

**Case** The center of a paper is stained with ink for the duplex printing.

The center portion of the switchback roller is dirty with ink.

- Wipe off ink from the center portion of the switchback roller.
- The switchback roller needs to be cleaned every 300,000 sheets printing.

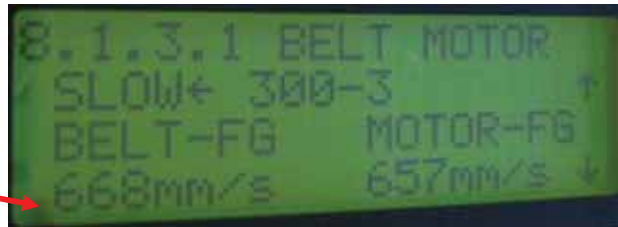
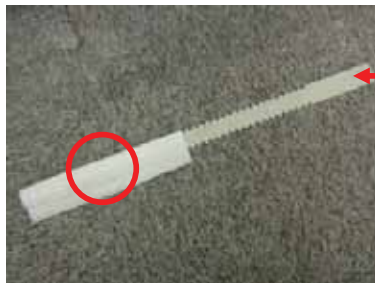
**The reverse surface of transfer belt is dirty with ink.**

- The transfer belt cannot rotate smoothly because there is a friction due to ink on the reverse surface of the belt.
- This trouble may be caused by the problem of non-stable rotation speed of the transfer belt and you can confirm whether it is in correct condition with **SE mode 8.1.3.1**.

Confirm if the BELT-FG speed is stable

- Clean the belt with cleaning jig or replace the transfer belt.

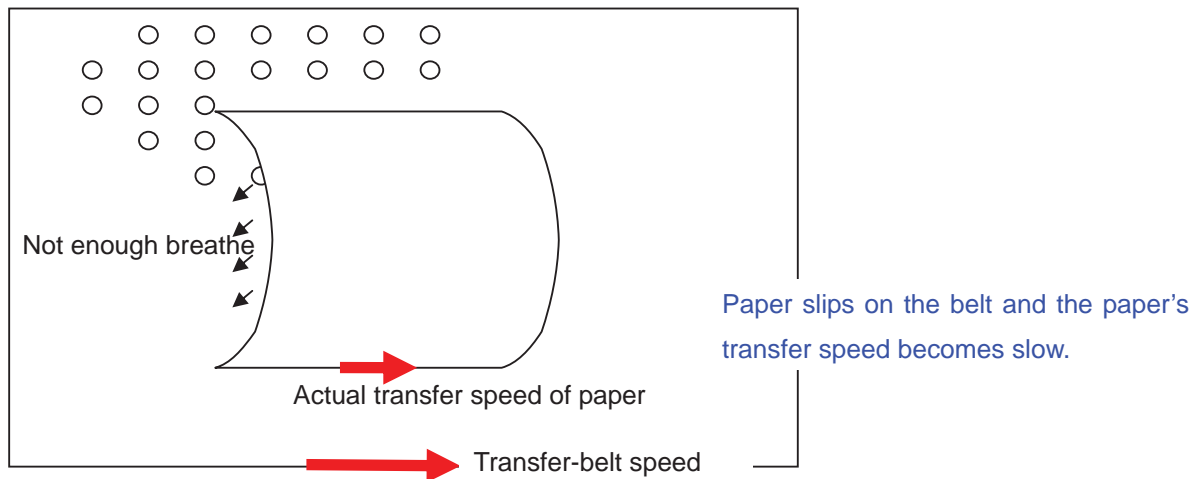
**Due to the paper condition, image shift occurs.**

- If curled papers are used, the paper touches with paper guide under maintenance unit.
- Paper can not breathe enough by the transfer belt if stiff papers are used. (Cardboard, Envelope ...etc)

- If stiff papers are used, be careful the paper condition (curl or wave)
- Post-card printing, paper-size detection sensor should be covered to be skip-printing mode.

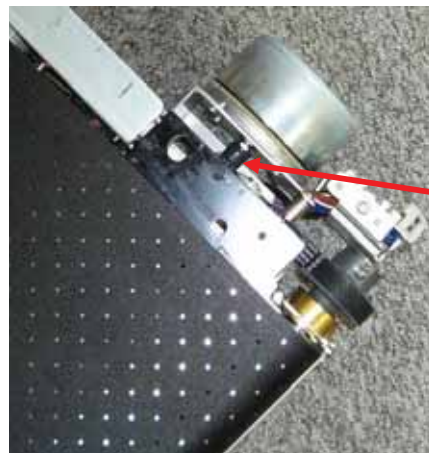
**Set-screw of the motor-gear loosens.**

- If the set screw of the gear loosens, transfer belt does not carry a paper with stability.

Please check whether the set screw does not loosen.

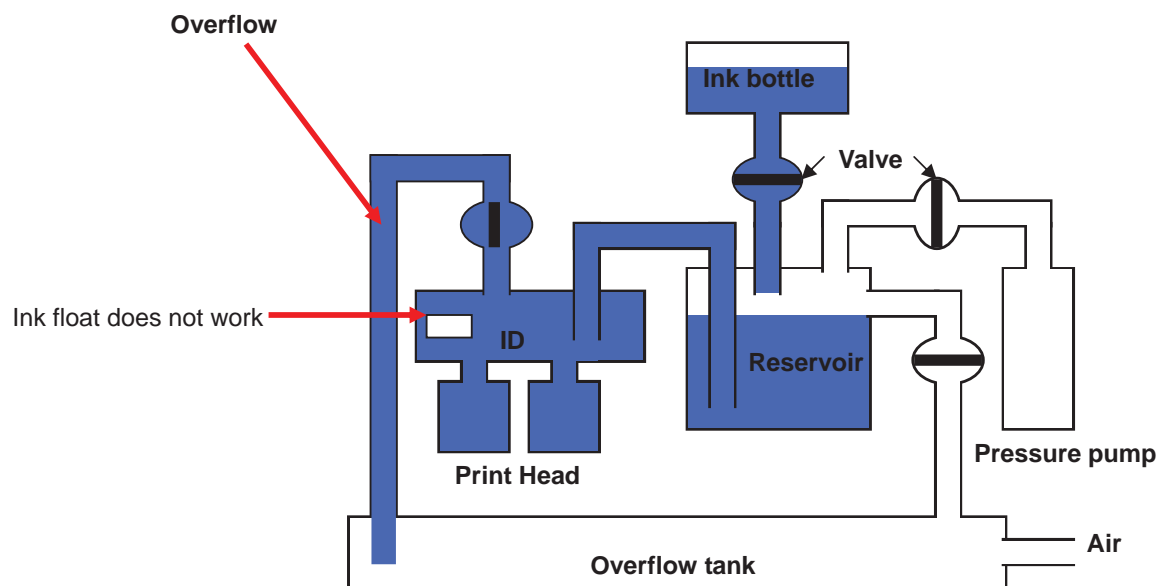
**Case** Ink flow from ID unit. Ink flow from ID solenoid valve.

→ Replace ID unit

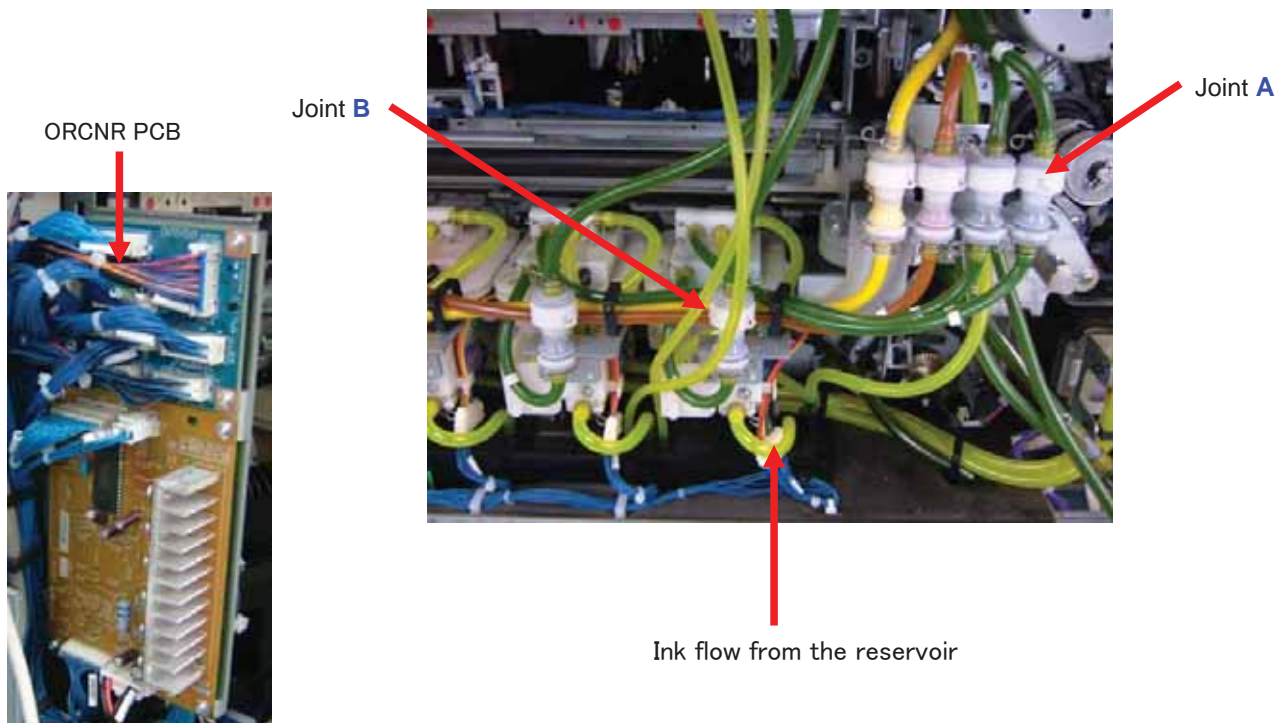
#### Cause of the problem

- After replace the **Print Head**, ink in the ID unit move to the reservoir for air in the **Print Head**.
- Air leak from ID unit or joint of **Print Head**.

- Dismounting a joint before changing **Print Head**, and connect it after open a [menu 5.5.5](#)
- Replace ID valve.
- Replace ID unit.
- Replace **Print Head**.

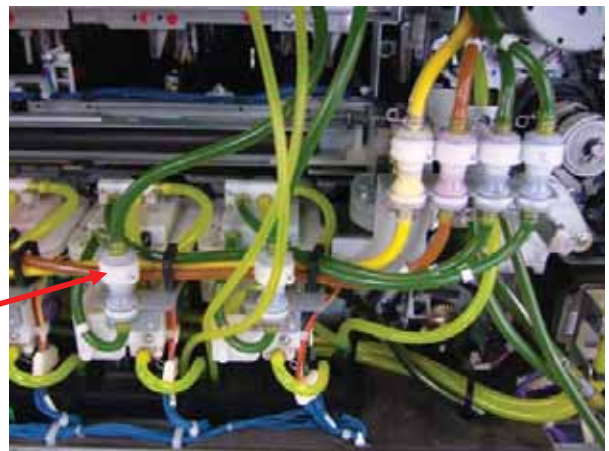
Joint **B**

**Case** After ID UNIT or Print Head is exchanged, Ink flow from reservoir

- When **ID unit** or **Print Head** is replaced, air is in **ID unit** so much.
- When much air is in **ID unit** or **Print Head**, ink flow to reservoir.
- If ink flow to reservoir, reservoir overflow.

- 1) Open the menu and select **menu 5.5.5**.
- 2) Start **menu 5.5.5**
- 3) Connect the joint **B** as soon as possible after start **menu 5.5.5**
- 4) Print Head cleaning action will be performed.
- 5) Confirm whether the transfer belt is not stained by ink before printing.

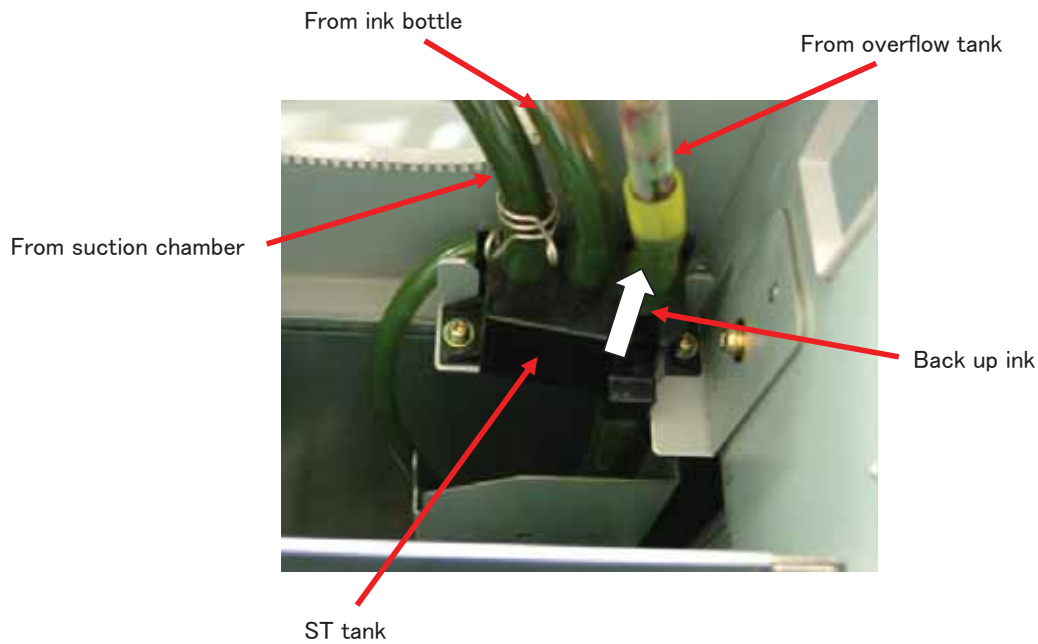
**Case** Ink flow from Suction chamber to Overflow tank.

- Check whether ink-hose which joint with **Waste ink tank** is twisted.
- Clean old Ink in the ST tank.
- Replace the ST tank.
- Replace the suction chamber.

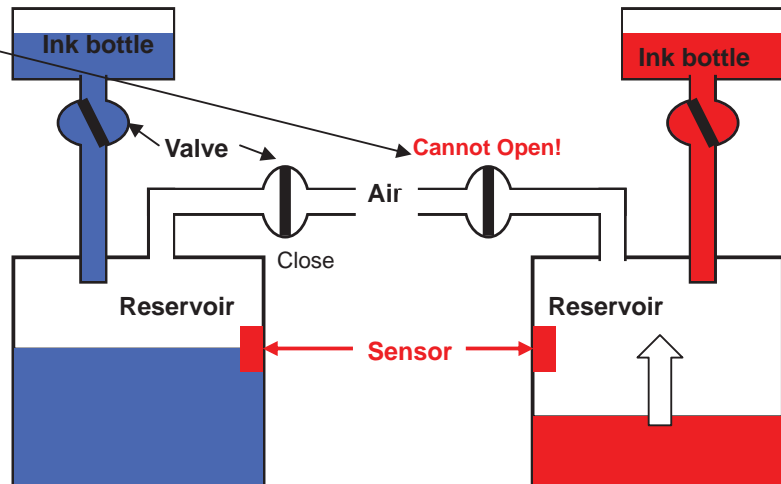
[ Reservoir(valve) is broken ]

Y01-328M display

Cannot rise!

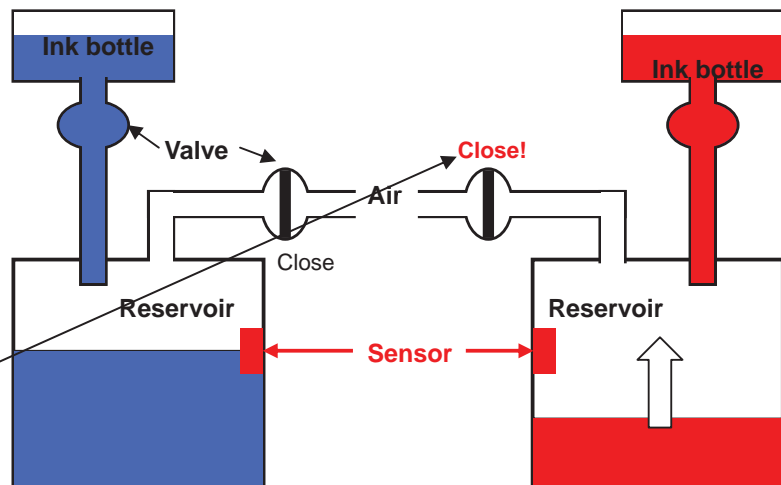
[ PCB is broken 1 ]

PCB detection is not correct

(Wire in the PCB break off)

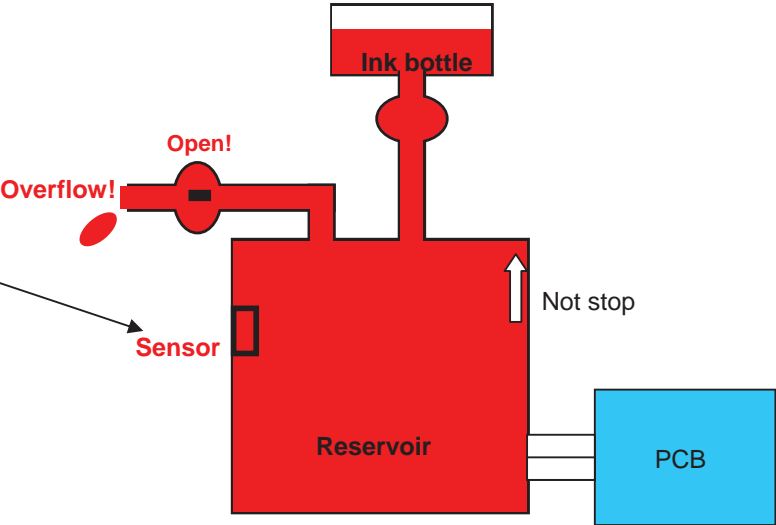
[ PCB is broken 2]

**PCB detection is not correct**  
(Wire in the PCB break off)

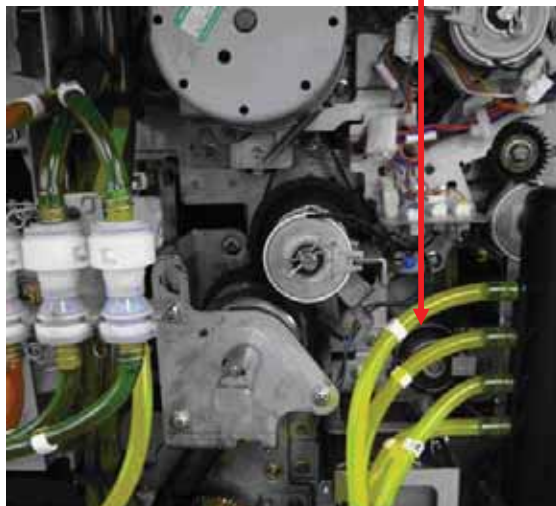
Multi-tray pickup clutch

- Paper jam that looks like bellows might occur at exit of multi-tray.
- Replace multi-tray pickup clutch

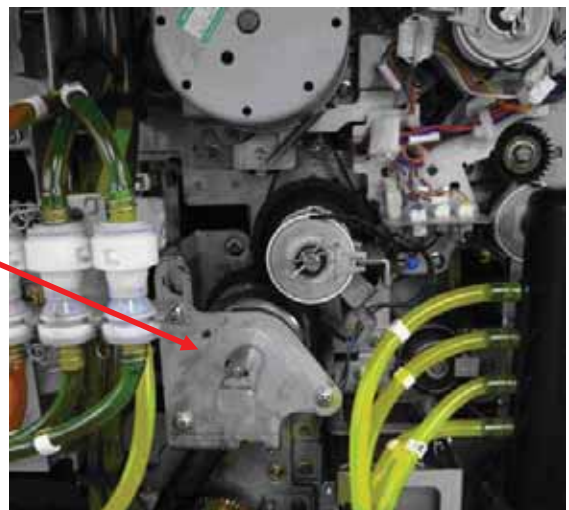
The vacuum positioning sensor fails to activate when the belt platen operates.

- Replace Lift gear unit clutch
- Apply grease under the transfer unit as follow to prevent this error again

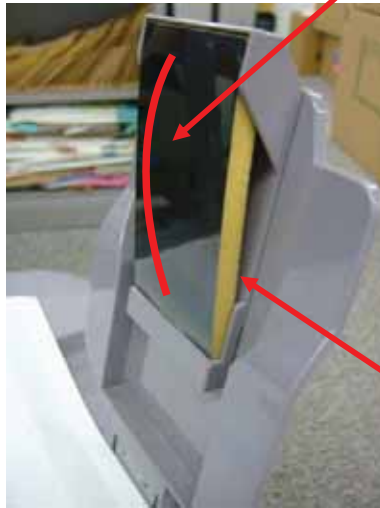
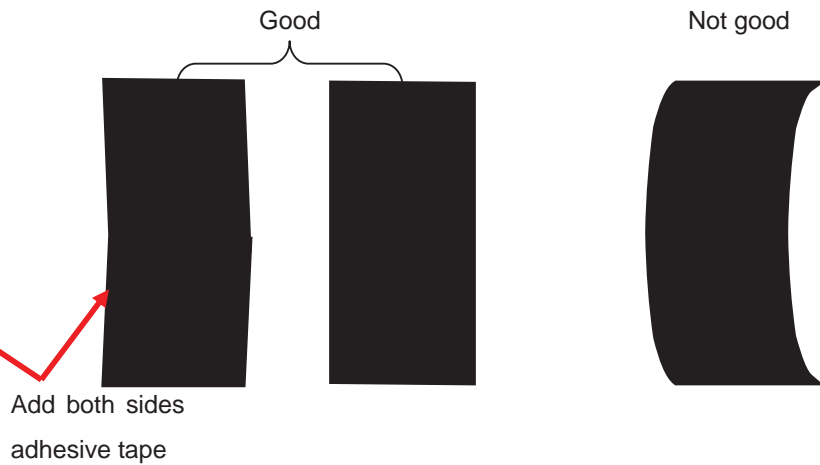
If this part is bent, ejected paper will bounce too much.

Concerning the width between the side-fences, top is slightly narrower about 5mm than bottom in normal condition.

If the width is not appropriate, the ejected papers curl and will be stacked up disorderly.

- Mend the end fence cushion if it is bent.
- Mend the angle of side fence if it is not suitable condition.
- Adjust the wing position of exit unit. (SE mode 5.9.1.40)
- Adjust the width of the side fence. (SE mode 5.9.1.60)

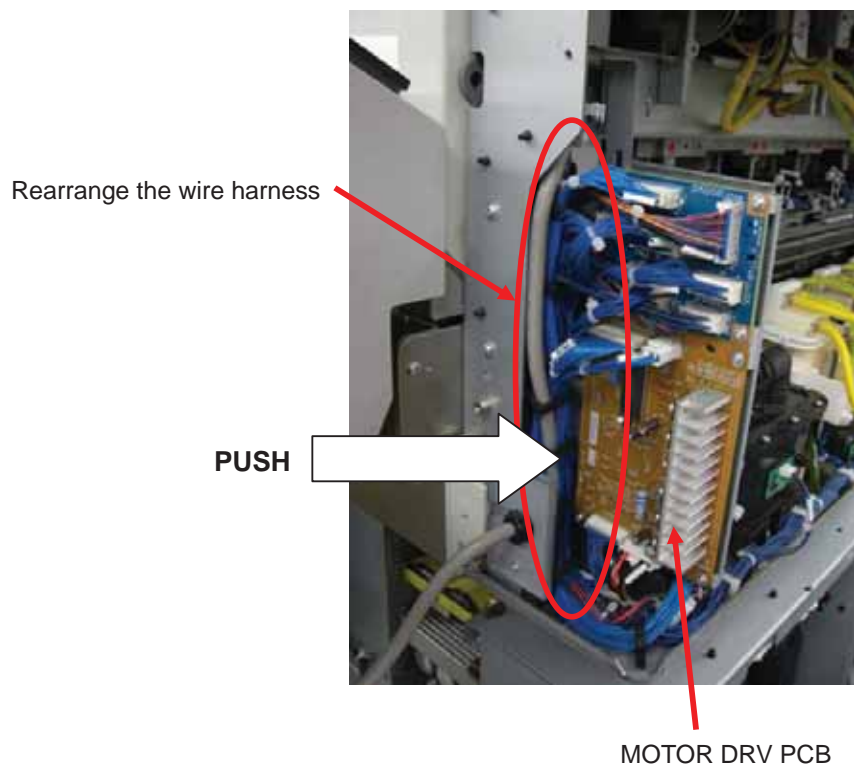
- MOTOR DRV PCB is broken.
- "Belt encoder sensor" can not work correctly if the sensor soaks with ink.
- If the MOTOR DRV PCB is pushed by wire harness or rear cover, the PCB is broken easily.

- Replace MOTOR DRV PCB.
- Replace BP unit or Belt encoder sensor.
- You should rearrange the wire harness before you replace MOTOR DRV PCB.

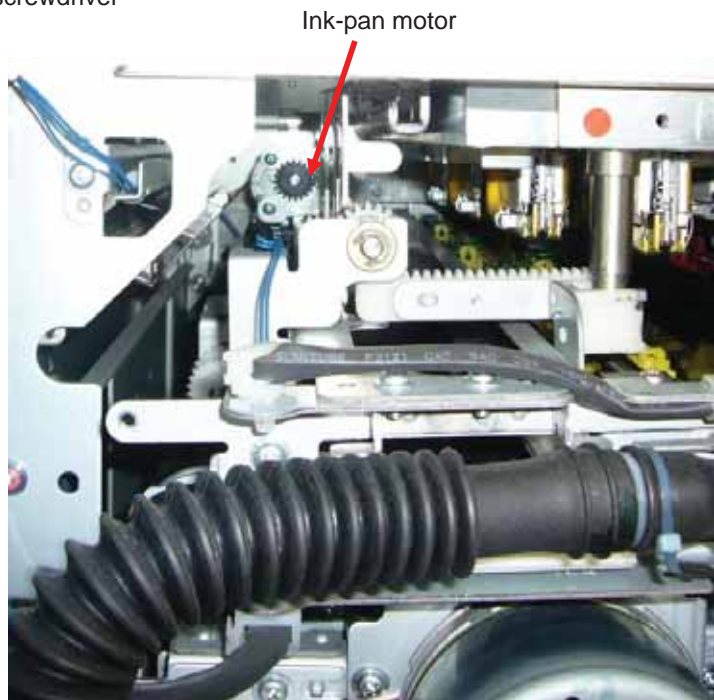
- If the screw of "Ink-pan motor" gets loose, it has left from the sensor easily.
- If the screw gets loose, **S04-300** error may occur depending on the situation.

- Check whether the screw of "Ink-pan motor" does not get loose.
- You can tighten the screw from back-side by a long screwdriver

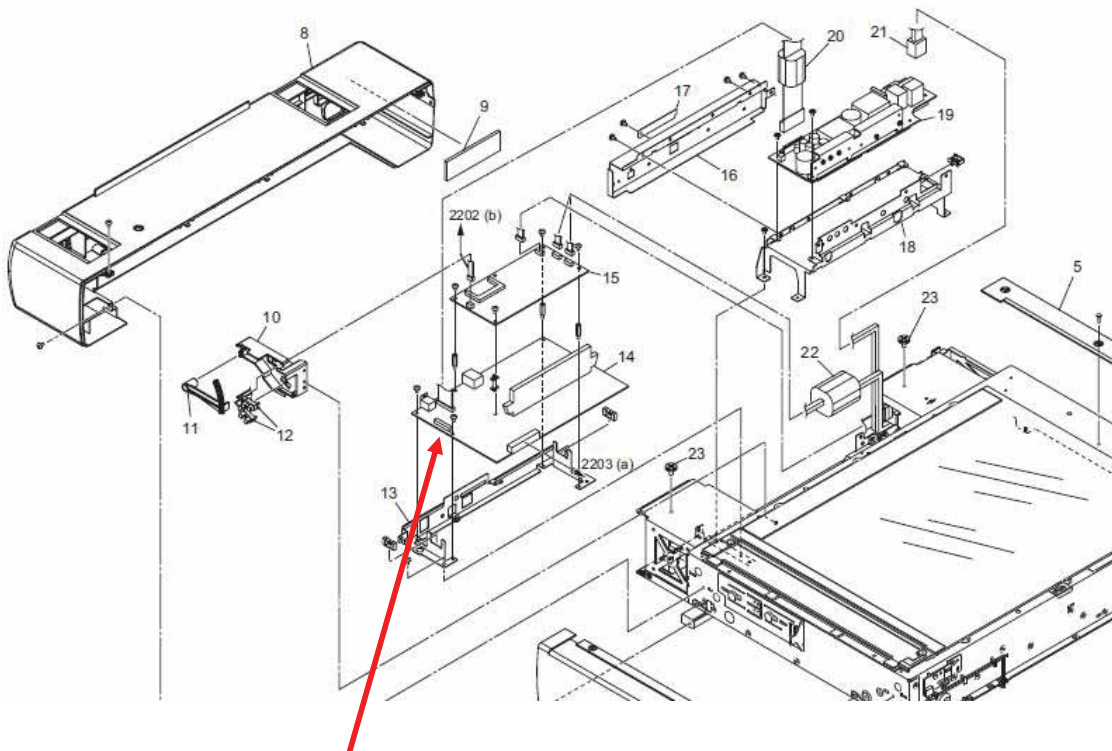
CS MAIN PCB 033-50500-803

- R98-142 error occurs when data is broken in EEPROM at optional scanner.
- If the error displayed on touch panel, please reset the data by following method.

- 1) Run SE mode for HS2000 on the touch panel.
  - 2) Perform **SE mode 385** and change a set value from "0" to "1".
  - 3) Reboot the HS2000.
- If the error has still occurred after executing this method, it is necessary to replace scanner PCB(CS MAIN PCB).

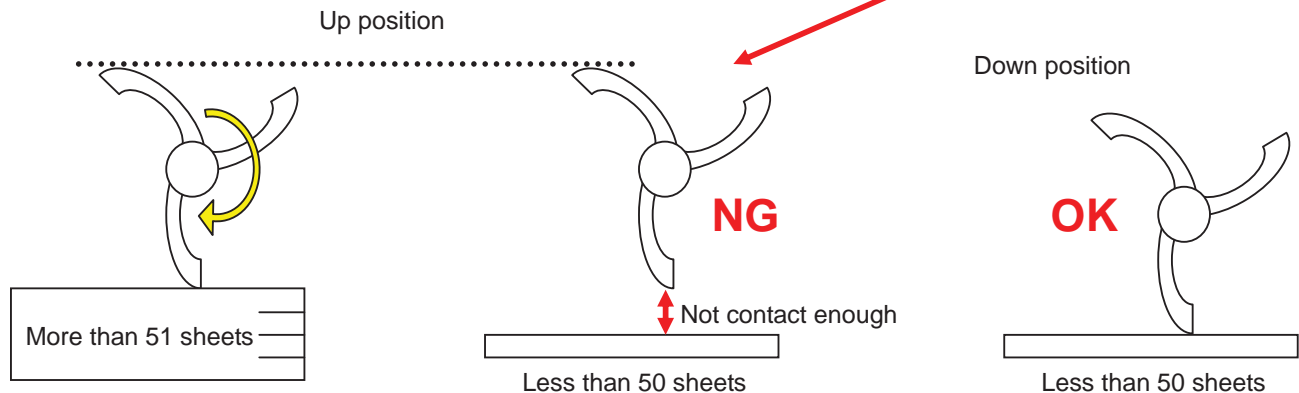
If the solenoid does not work, Sub-paddle cannot contact papers properly.

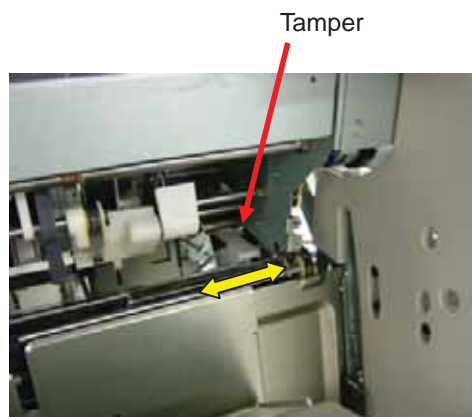
(Ref-C)

If tamper dose not move smoothly, papers cannot aligned properly.

Clean the tamper and tamper motor or replace the tamper motor and timing belt

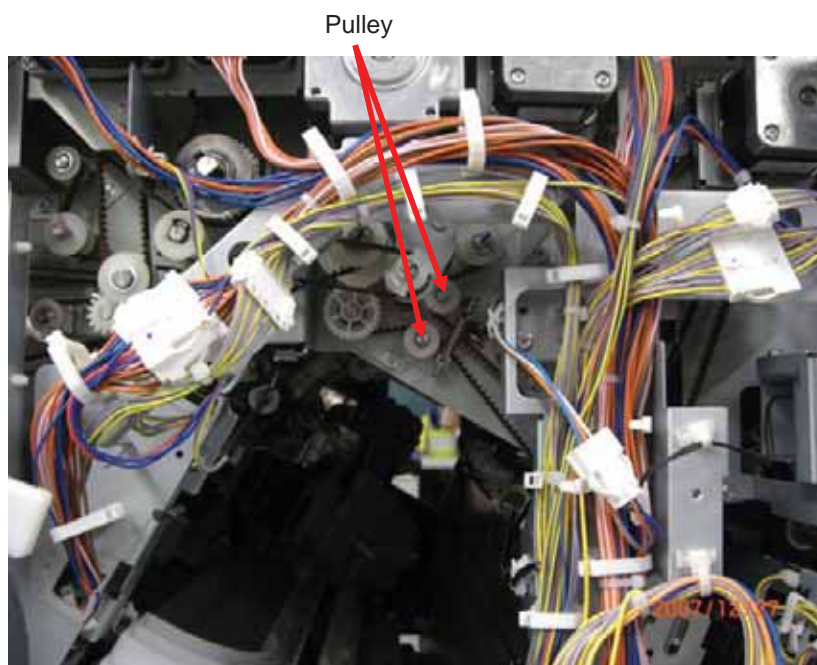
#### A paper does not reach to eject sensor

- If a paper does not reach to the eject sensor, it is almost displayed **X19-711 error**
- Check whether the pulley and belt which move the exit roller is smooth.
- There are some pulleys on the mechanism; the belt is a little long.
- In case the movement of these pulleys is not smooth, the exit roller can not eject a paper to eject sensor in time.
- Clean the inside of the pulley.
