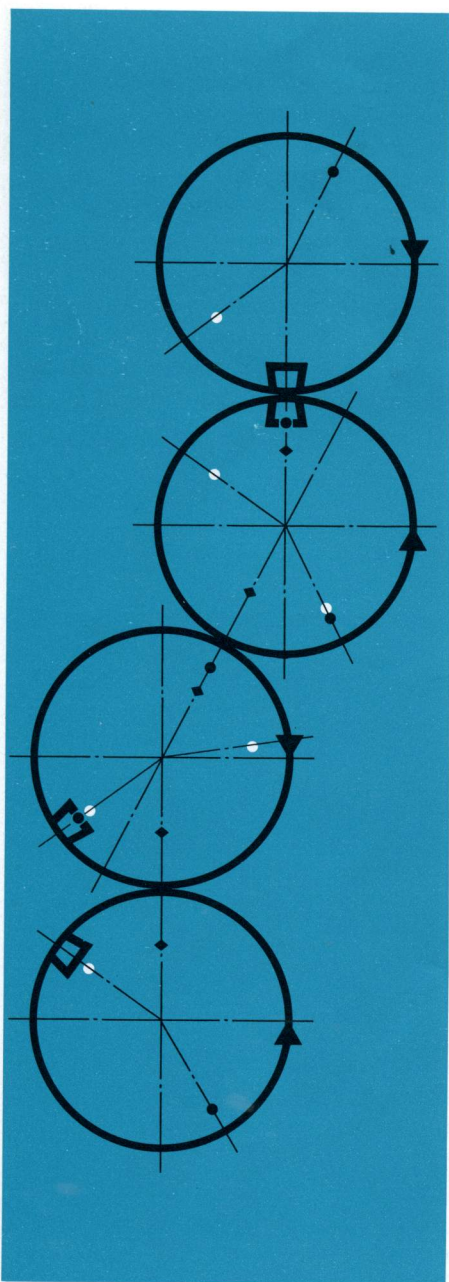
Fig. 21 54° later: coincidence of top plate and blanket cylinders and their subsequent effects on bearers between blanket cylinders and between plate and blanket cylinders of bottom printing unit.

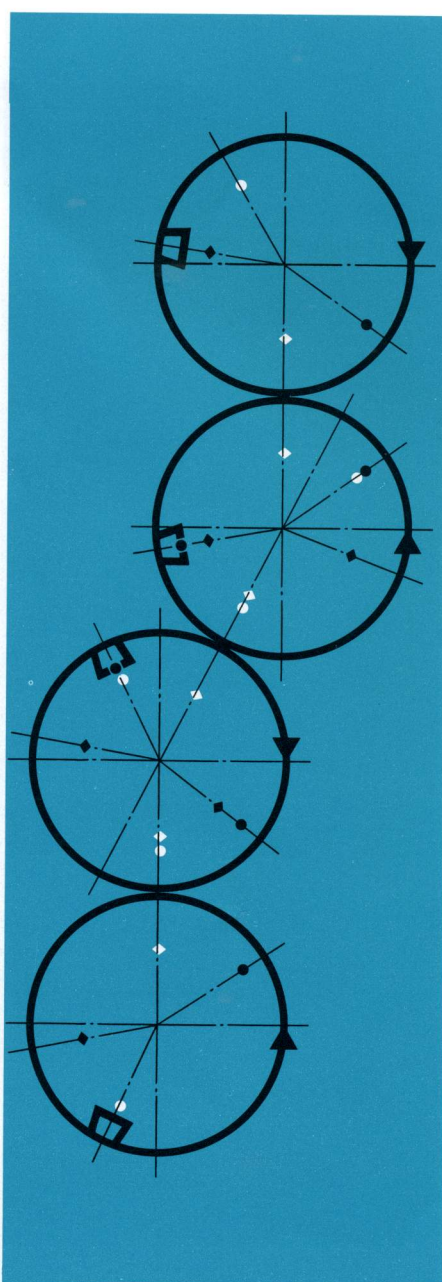
Fig. 22 Depiction of cylinder after turning another 99°, with marks caused by cylinder bounce, as shown in previous diagrams, reaching areas of bearer-to-bearer contact between blanket-to-blanket cylinders and between blanket and plate cylinders. These may give rise to consequential damage.

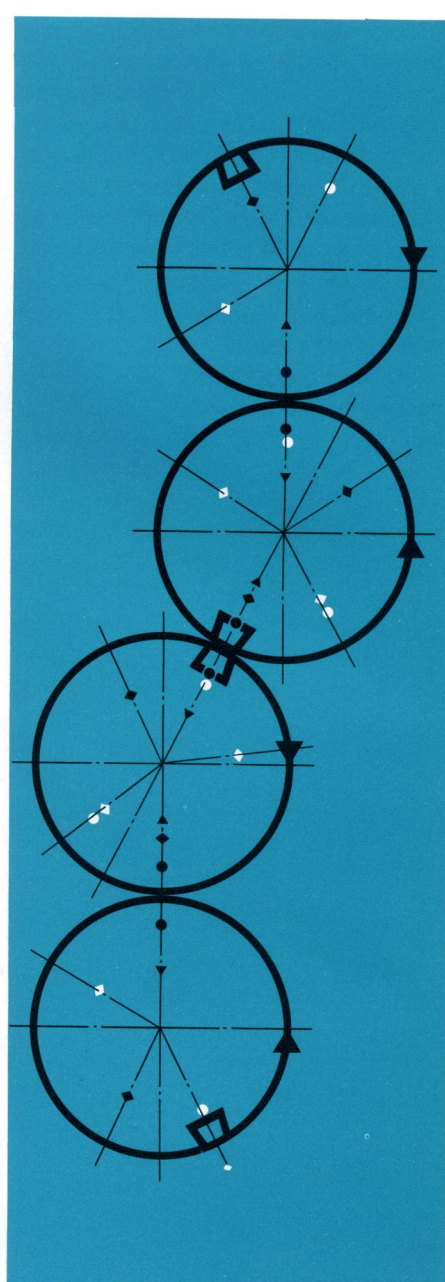
Fig. 23 54° later: cylinders have now rotated through 360° and returned to initial position as shown in Fig. 19, where blanket cylinder pits are facing.
