# 1.3.8. Rough image on the 1st side of duplex

# 1.3.9. White or color banding at thick paper leading and trailing edges

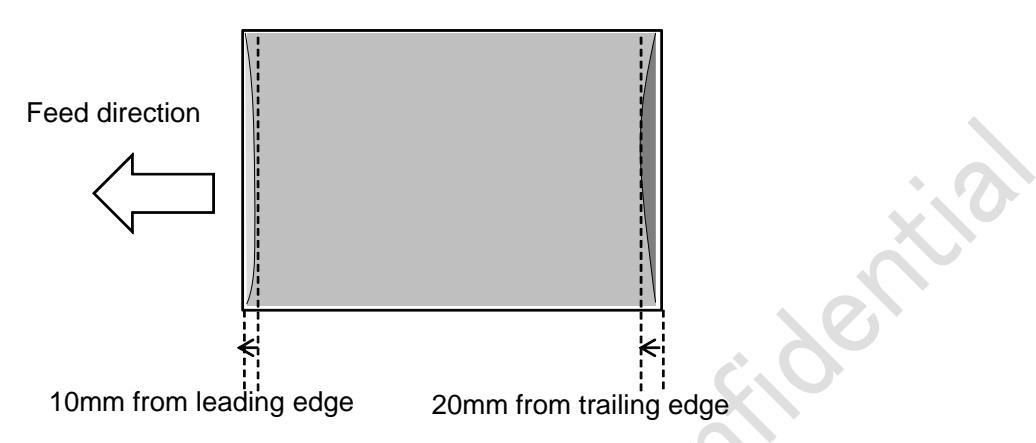
On thick paper, white or color banding appears at 5 to 10mm from leading edge and 20mm from trailing edge.

White band: Void due to abnormal discharge

When very stiff paper is fed, the paper pushes up the intermediate transfer belt when the leading edge or trailing edge of the paper enters to the 2<sup>nd</sup> transfer nip. The belt and paper does not contact at that point causing abnormal discharge. The toner reversely charged is not transferred to the paper and looks like void (white spot).

• Color lines: Shock generated when the trailing edge exit the 2<sup>nd</sup> transfer front guide and blur due to abnormal discharge.

When very stiff paper exits the 2<sup>nd</sup> transfer front guide, the paper hits the belt strongly and generates shock. The shock makes the image on the belt blurred.

- (a) Change 2<sup>nd</sup> transfer pressure
  - 1. Change DipSW1-0 from 0 (Default) to 1, to show expert adjustment on paper settings.
  - [Machine]→[Paper Setting]→[Change Set.]→[Expert Adj.] [2<sup>nd</sup> Trans. Pressure] Select [Normal]

When [Normal] is selected, color line in main scan direction (CD) may appear at 105mm from leading edge. If it is noticeable, set the setting to auto and go to step 2 in below. If the improvement level is not enough, without reset the setting, go to the step 2, 2<sup>nd</sup> transfer output adjustment.

(b) 2<sup>nd</sup> transfer output adjustment

- 1. To show expert ad DipSW1-0 from 0 (Default) to 1.
- 2. Adjust  $2^{nd}$  transfer current at the banding occurring part. [Machine] $\rightarrow$ [Paper Setting] $\rightarrow$  [Change Set.]  $\rightarrow$  [Expert Adj.]:

[2<sup>nd</sup> transfer-Lead Edge (Front)], [2nd transfer-Lead Edge (Back)], 2nd transfer-Rear Edge (Front)] or [2nd transfer-Lead Edge (Back)]

If output is reduced too much, poor 2<sup>nd</sup> transfer occurs. Please adjust while checking actual print image.

(c) Change paper face (turn around the paper in the tray)
