Toner Scattering: Trailing Edge

Published 06/24/2018 10:36 PM | Updated 07/09/2018 12:03 AM | Answer ID 258002

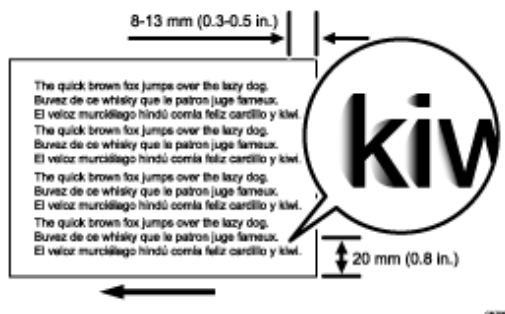
Parts of a line or character exhibit splatter. This may occur in a line or character that is 8 to 13 mm (0.3 to 0.5 inches) from the trailing edge and 20 mm (0.8 inches) or less from the left edge facing the paper feed direction.

A shock jitter occurs when the trailing edge of the paper leaves the paper guide during paper transfer and causes toner scattering.

This may occur if paper with a thickness equivalent to Paper Weight 4 or higher is used.

1. In **[Advanced Settings]** for the custom paper, select 1217: **[Paper Transfer Output Correction: Paper Edge]**, and then set **[Trailing Edge]** of **[BW]** to "10".
2. Select 1217: **[Paper Transfer Output Correction: Paper Edge]**, and then set **[Trailing Edge Length]** of **[BW]** to "30 mm".
3. Select 1212: **[Image Transfer Output]**, and then check the value in **[Black]** of **[BW]**. Is it "10"?
Yes: No further improvement is likely. Contact your service representative.
No: Increase the value in **[Black]** by 1.
4. Print the image. Has the problem been resolved?
Yes: Finished!
No: Repeat Steps 3 and 4.

1. In **[Advanced Settings]** for the custom paper, select 1217: **[Paper Transfer Output Correction: Paper Edge]**, and then set **[Trailing Edge]** of **[FC]** to "10".
2. Select 1217: **[Paper Transfer Output Correction: Paper Edge]**, and then set **[Trailing Edge Length]** of **[FC]** to "30 mm".
3. Select 1212: **[Image Transfer Output]**, and then check the value in **[Black]** of **[FC]**. Is it "10"?
Yes: No further improvement is likely. Contact your service representative.
No: Increase the value in **[Black]** by 1.
4. Print the image. Has the problem been resolved?
Yes: Finished!
No: Repeat Steps 3 and 4.
