# HC Series Troubleshooting

Rev. 1.6

RISO KAGAKU CORPORATION  
Overseas Technical Department  
12 February 2008

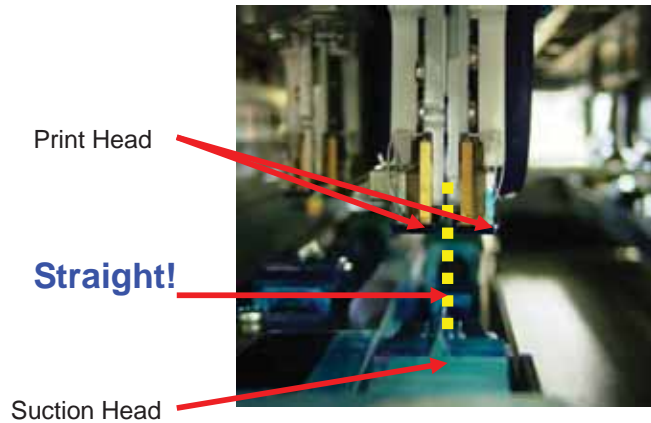
**There is a problem in the stopping position of maintenance unit.**

- If the stopping position of maintenance unit is not proper during Print Head cleaning operation, Suction head cannot wipe the surface of Print Head sufficiently.

- If there is a problem with the stopping position of maintenance unit, Ink might drop down from "Ink Pan" because the "Suction Head" touches "Ink Pan".

- Repair the deformed unit or replace the unit.

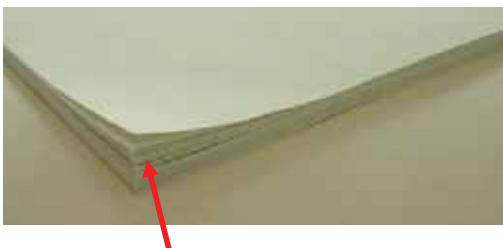
Curl of paper

Due to curled paper or waved paper, edge of paper is stained.

- If curled paper or waved paper is used for printing, the paper will touch the surface of Print Head slightly and the leading edge of the paper will be stained with ink.
- In worse condition, the error **X02-223** [Paper lift detection] will occur.

- Change papers with non-curved and non-waved papers if possible.
- Change the paper feeding direction if the paper size is small or than A4. (Short edge paper feeding -> long edge paper feeding)
- Use the paper feeding from Multi-Tray Paper Feed Tray to avoid influence of the outside air. And putting "silica gel" is effective for humidity.
- Remedy of paper curl.

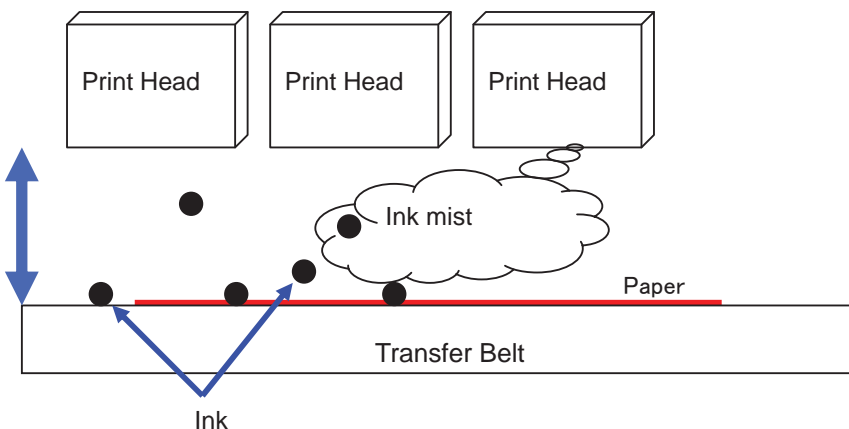
The gap is big

**The gap between Print Head and the transfer belt is too far.**

- Ink mist, a minute particle of ink, may be sometimes generated from Print Head during printing.
- Such ink mist drifts in the air and comes toward the transfer belt.
- Most of them reach to the paper on the transfer belt so it is a problem.
- But if the gap between Print Head and the transfer belt is too far, misting ink may reach to the transfer belt and it can be misting a cause of the problem.
- As a result, the surface of the transfer belt becomes dirty with ink and the edge of paper gets stained with ink.
- If the margin around the printing paper is reduced by **menu 4.10** [Print Area], this problem occurs easily.

- Adjust the gap by **SE mode 5.9.1.32** for HC5000. (It is possible to widen with 0.1mm step)
- The gap is alternated automatically by the paper type. If you print normal paper with envelope setting, the gap becomes too big.(HC5500)
- Adjust print area(margin) by **menu 4.10**.(HC5000, HC5500)

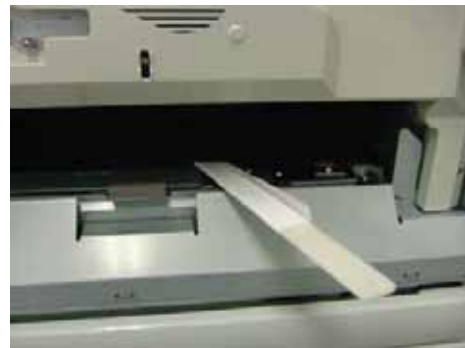
Cleaning jig

- The transfer belt cannot rotate smoothly because there is a friction due to ink on the reverse surface of the belt.
- This trouble may be caused by the problem of non-stable rotation speed of the transfer belt and you can confirm whether it is in correct condition with **SE mode 8.1.3.1**.

- Clean the belt with cleaning jig or replace the transfer belt.

Wrap the cleaning jig with paper and moisten it with alcohol.

Insert the jig under the transfer belt and clean the transfer belt by move it in right and left.

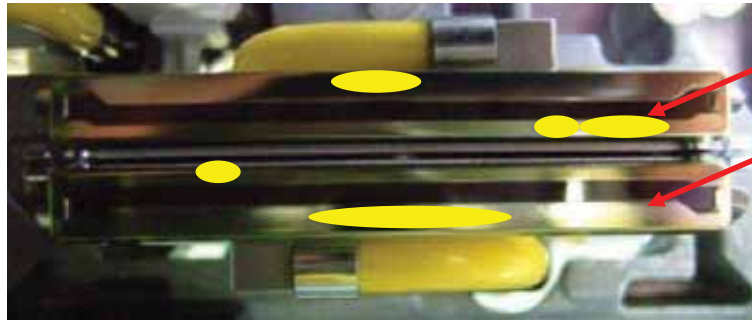
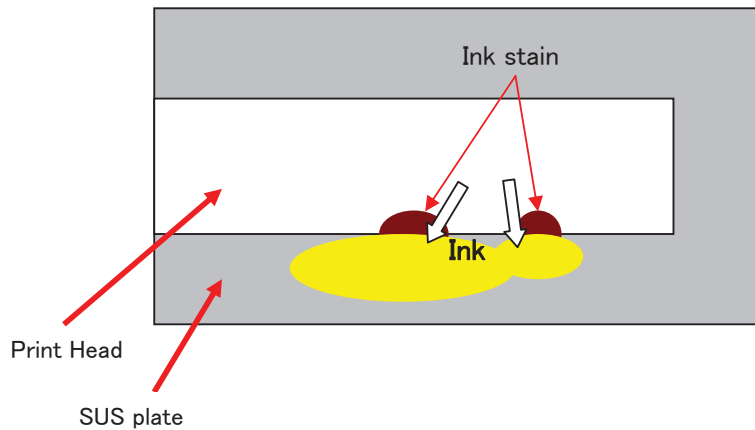
**Case** Cleaning method of Print Head which has stain of SUS plate problem.. (magenta or yellow Head)

If the surface of the SUS plate is dirty with remaining old ink, ink will spill out from Print Head along the remaining ink.

Use fresh HC ink and wipe-stick

Clean enough both Print  
Head and SUS plate

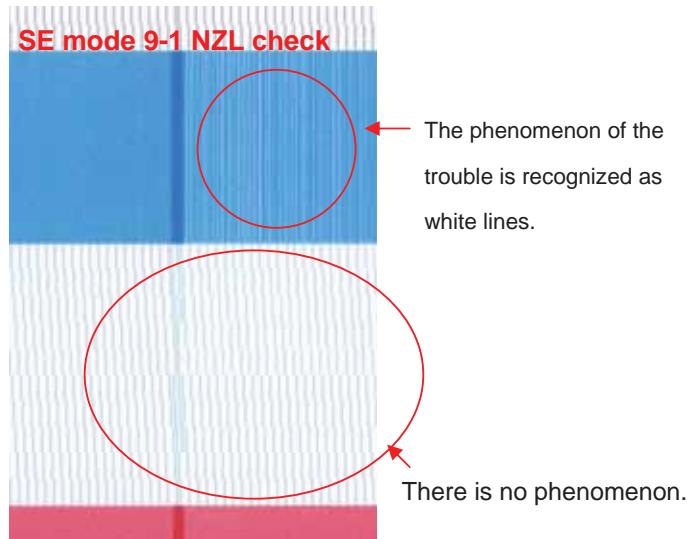
#### [ In case of miss-direction ]

- Ink ejects down from all piezo-nozzle of Print Head but it seems that ink goes down in irregular direction.
- Use A and B cleaning fluid for Print Head cleaning.

- 1) Apply 'A' fluid to the Print Head with a wipe stick.  
(Don't scrape)
- 2) Perform **SE mode 5.5.4.2**
- 3) Apply 'B' fluid to the Print Head with a wipe stick.  
(Don't scrape)
- 4) Perform **SE mode 5.5.4.2**
- 5) Check by **SE mode 9.1**  
Same action should be repeated if not improved.

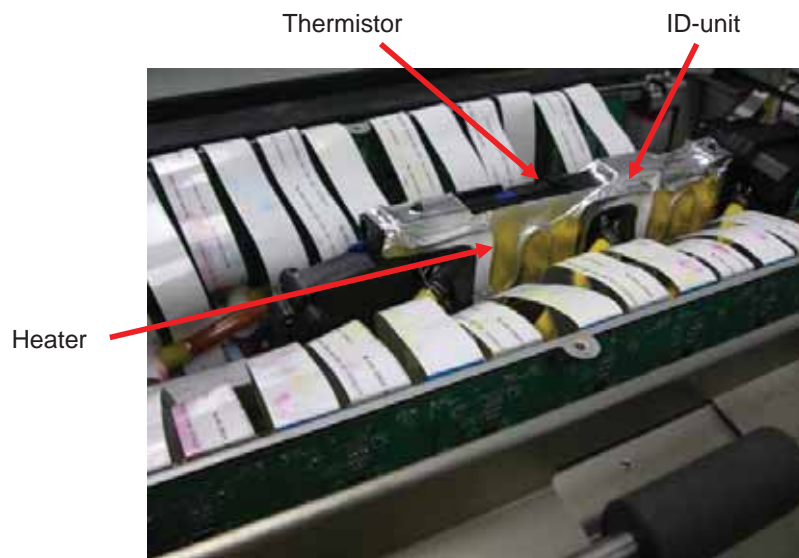
- If “a thermistor of ID-unit” does not work normally, HC try to print with cold ink. Then “White line” occurs easily.
- If “white line” occurs by the same color every time, it is necessary to replace ID-unit.
- You can check temperature of ID-unit by **SE mode 8.2.8.5**.

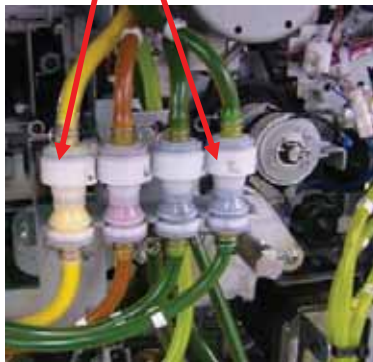
- This error will be displayed in the case that the sensor in the reservoir can not detect the presence of ink.
- After setting ink cartridge, from 50 to 60 seconds later, this error is displayed again.

- Ink fuse solenoid valves which connect with reservoir can not open enough.
- Joint of ink passage does not connect certain.
- Solenoid valves in the reservoir can not open enough.
- OR-CNR-PCB which leads to a reservoir is broken.

- Check whether Joint of ink passage is correct.
- Check whether ink-tubes from cartridges are having stress or twisted.
- Replace reservoir and OR-CNR-PCB and Ink fuse solenoid.

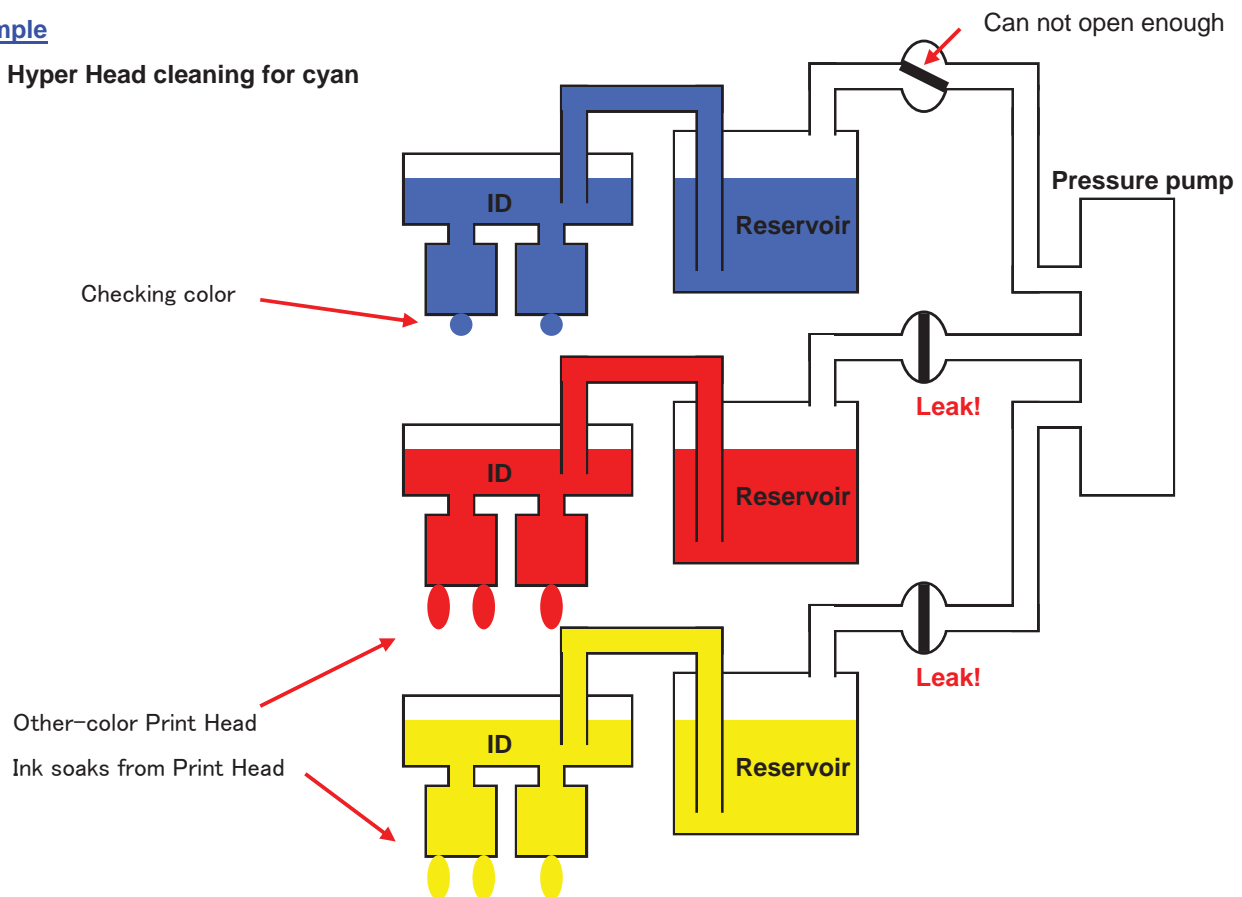
Start Hyper Head cleaning for cyan

If valve of checking color can not open enough, Ink soaks from Print Head of other color too.

**Then decrease of problem ink is smaller than decrease of be calculated on the printer.**

- Do Hyper Head cleaning(SE mode 5.5.4.x) of problem color, then confirm whether ink does not soak from **other-color** Print Head
- If ink soaks from **other-color** Print Head, replace reservoir of **problem-color**. And more do Head cleaning
- If ink does not soak, replace pressure pump.
- Y01-329 trouble have still occurred after replace these parts, replace pressure chamber.

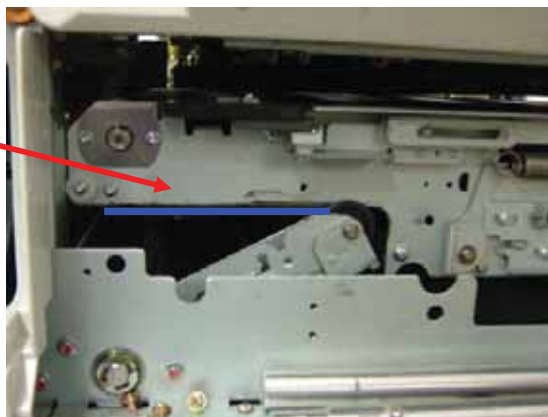
- Replace Lift gear unit clutch
- Apply grease under the transfer unit as follow to prevent this error again

Please apply grease on this point

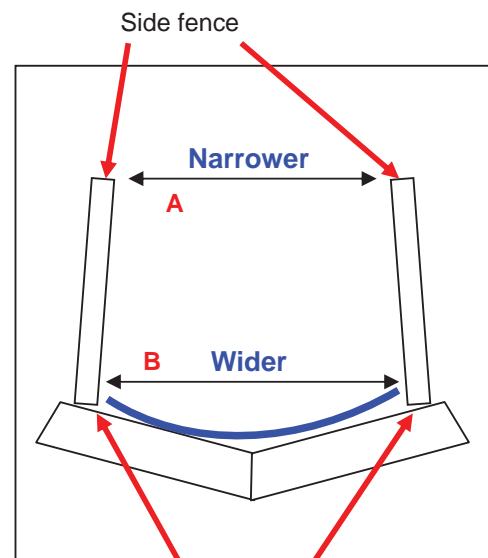
Concerning the width between the side-fences, top is slightly narrower about 5mm than bottom in normal condition.

If the width is not appropriate, the ejected papers curl and will be stacked up disorderly.

$$B - A = 5\text{mm}$$

Add plate to change angle

- Mend the end fence cushion if it is bent.
- Mend the angle of side fence if it is not suitable condition.
- Adjust the wing position of exit unit. (SE mode 5.9.1.40)
- Adjust the width of the side fence. (SE mode 5.9.1.60)

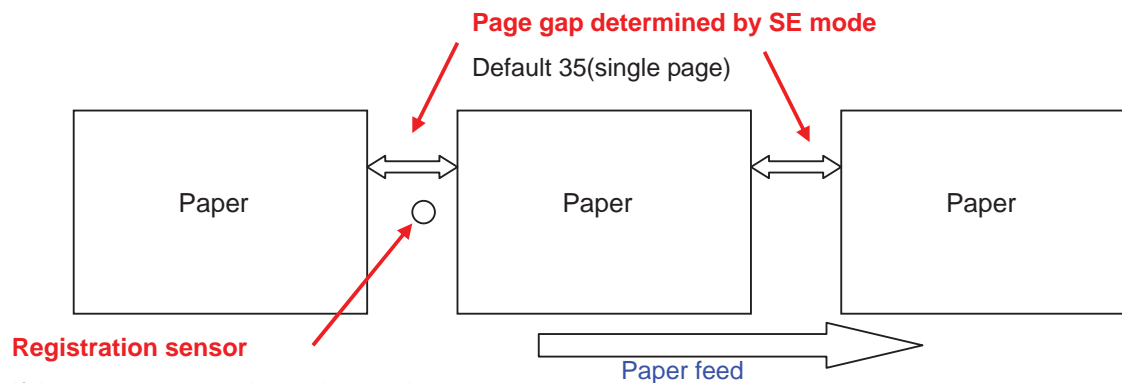
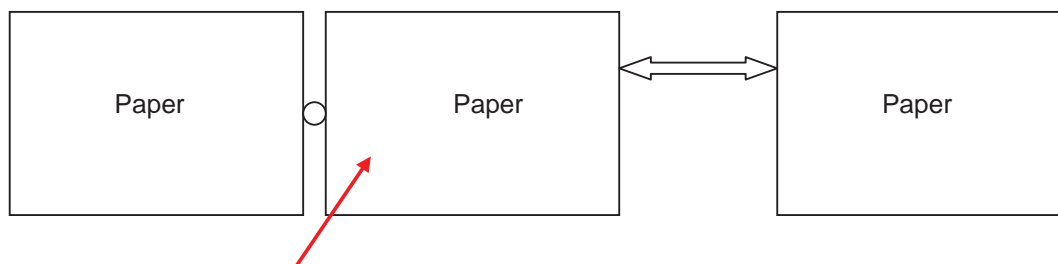
If the sensor cannot detect the gap between the papers, **X02-210 error** occurs.

Even if the paper feeding get delay by some reasons and the gap become narrow, the sensor can detect the gap if the gap is adjusted widely enough.

- Confirm whether papers are fed smoothly from multi-tray.
- Adjust pressure and angle of pad at multi tray.
- Confirm whether warped post cards are used.
- Increase the value of **SE mode 5.9.1.30** (single page gap) from 35(default) to 45.
- Increase the value of **SE mode 5.9.1.31** (duplex page gap) from 60(default) to 70.
- These values can be set individually by the paper type and if the value is increased, the printing speed will get slow.

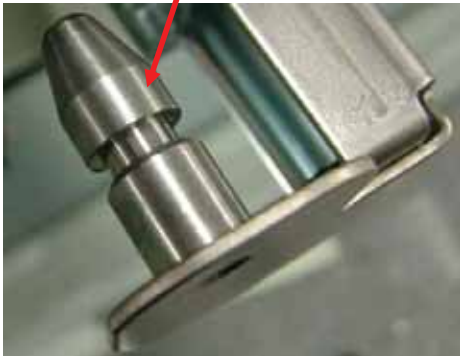
Front side lock shaft

- The lock shaft of the front side of duplex unit is out of position.
- The lock plate cannot move smoothly.
- The screws mounting the guide shaft of the rear side of duplex unit are loosened.

- Check the movement of lock plate is smooth.
- Reform the front side lock shaft.
- Check the screws of guide shaft

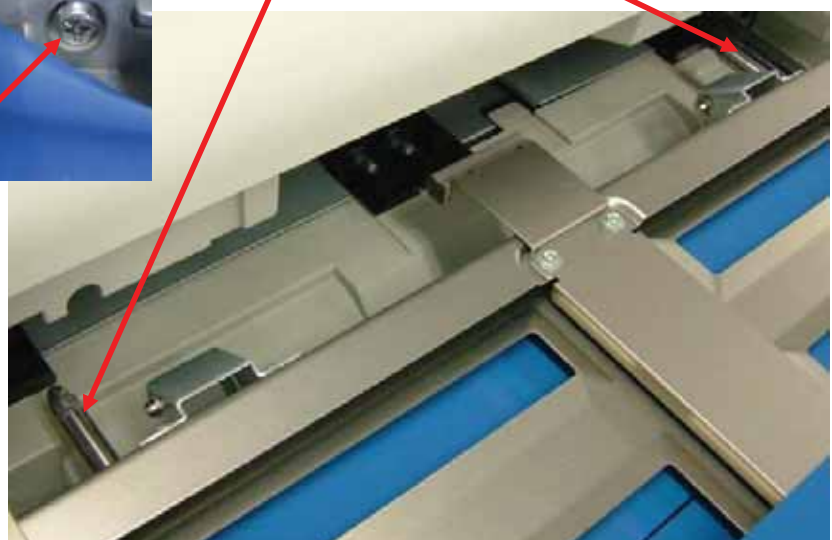
Gear

Screw

Guide shaft

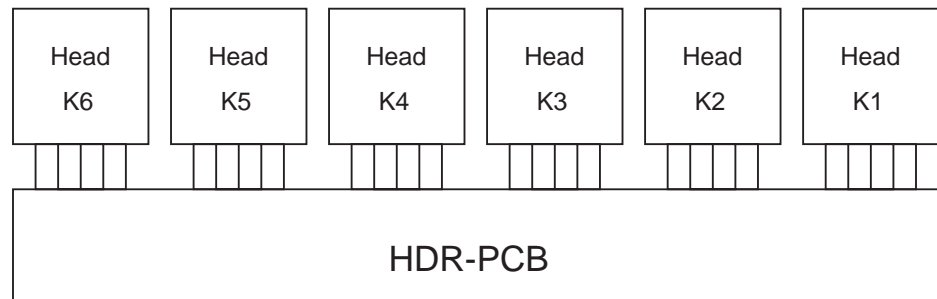
Displayed **S98-320 K1**

- S98-320 error is displayed when short circuit occurs in print head or HDR-PCB
- Print head number is displayed after this S98-320 error usually.

- Clean flat-cable between HDR-PCB and print head.
- Preparing new Print Head, and it connects to the HDR-PCB in turn.
- If the error is not displayed when connecting other print head with **specific "Print Head No"**, the print head has been damaged.
- If the error is still displayed though all print heads have been checked, it is necessary to replace HDR PCB.

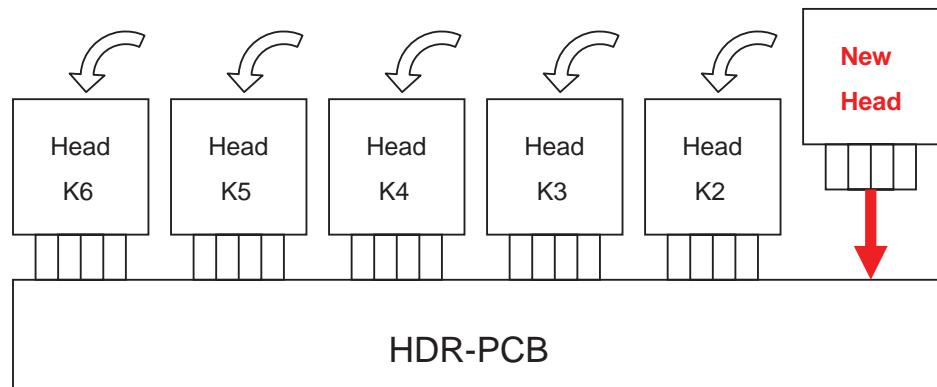
Connecting new Print Head in turn

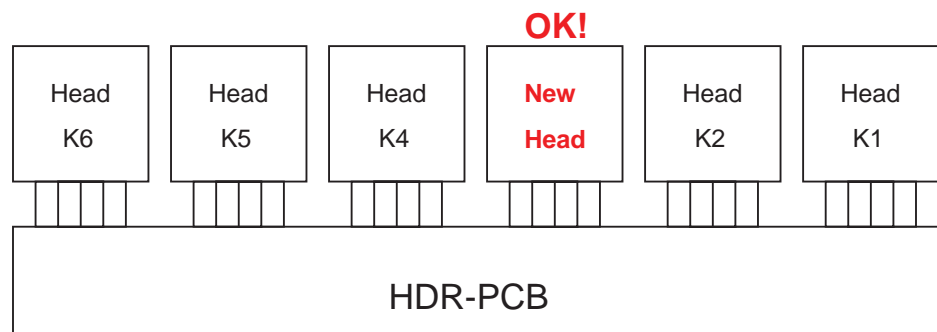
You can check which print head has been damaged.

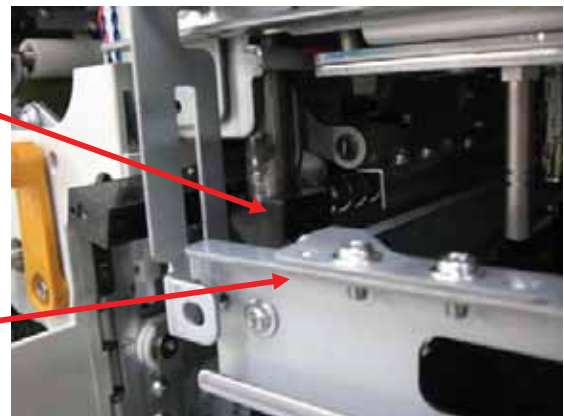
Slide hole

- Check whether the slide hole on the maintenance unit has moderate grease.
- If this part does not have any grease, S03-201 error occurs easily.

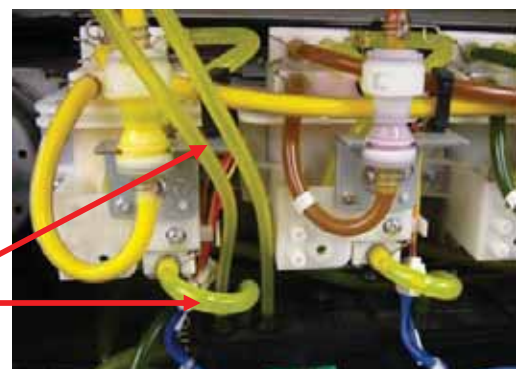
- Check whether the movement of stripper shaft in multi tray unit is smooth
- Confirm whether Print-heads take opposite position with Suction Head straight.
- Check whether Ink have never flowed from reservoir to overflow tank.

Ink does not usually flow in this tube

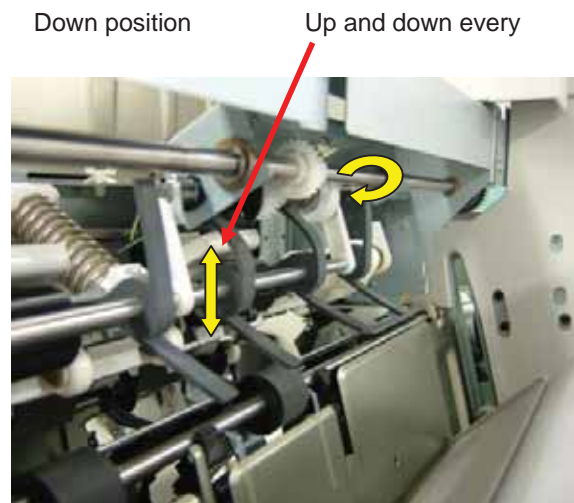
If **Sub-paddle** does not move up and down properly, contact with a printout and paper jam occurs easily.  
Confirm whether paddle clutch and Sub-paddle home sensor work properly.

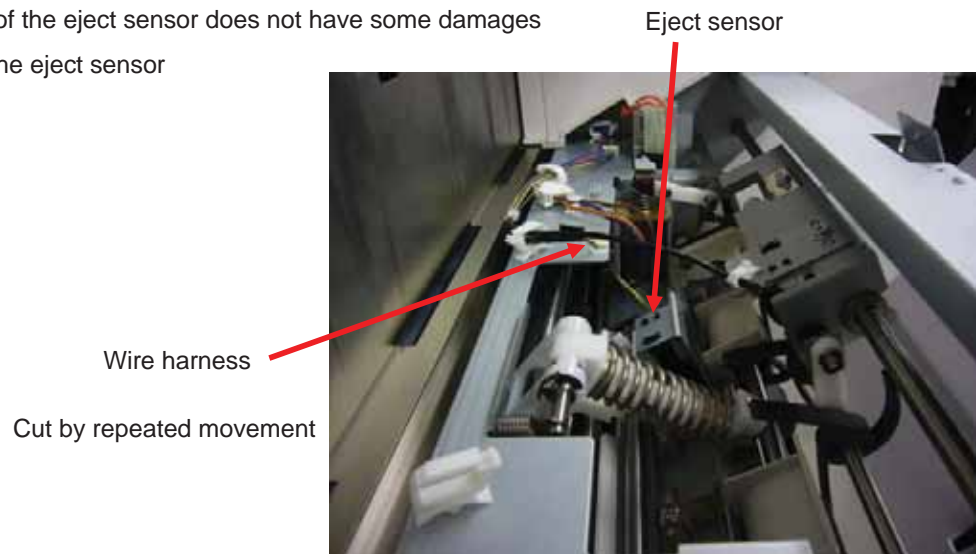
#### A paper reaches to eject sensor

- Check whether wire harness of the eject sensor does not have some damages
- Replace the wire harness of the eject sensor
